Evaluating Surface Preparation for Maintenance Recoating: Testing Waterjetting, Salts, Inhibitors

Presented by: Alex Petkas, PhD., HoldTight Solutions, Inc.

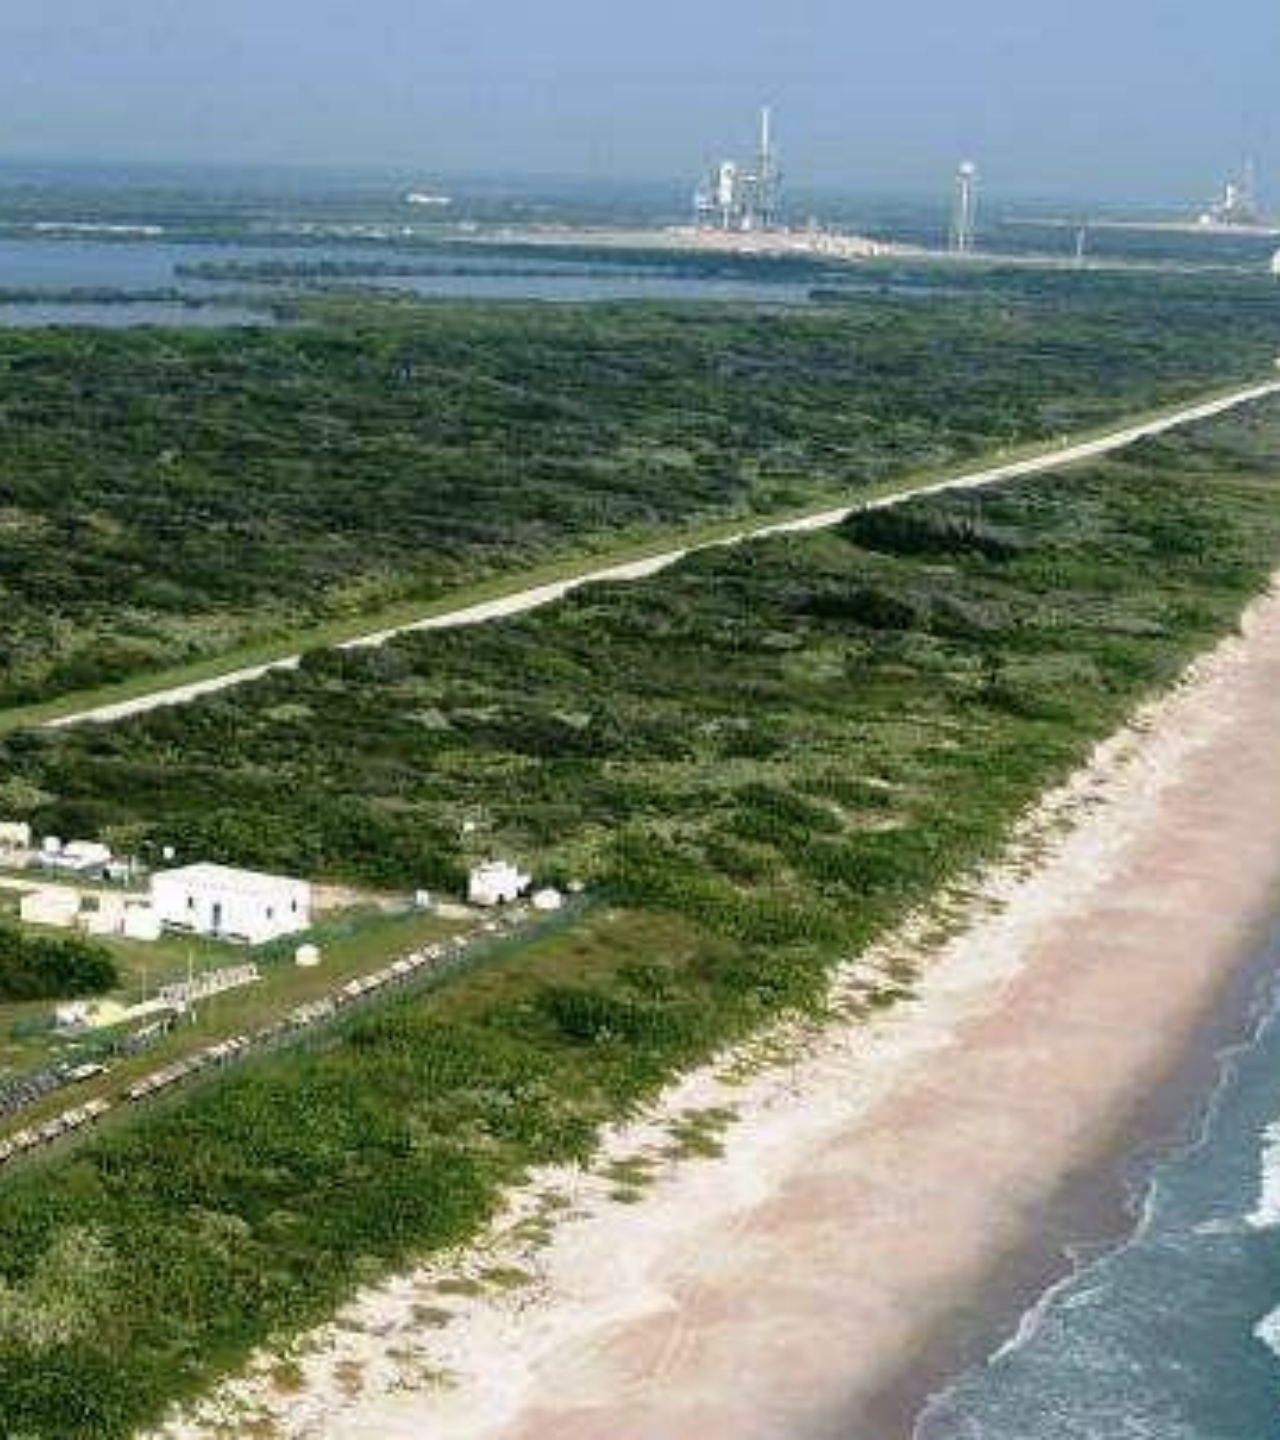
NASA BEACHSIDE CORROSION
TESTING FACILITY

- ASTM G50 used for long term field exposure test
- Racks are 150 ft from high tide line

KENNEDY SPACE CENTER,
FLORIDA

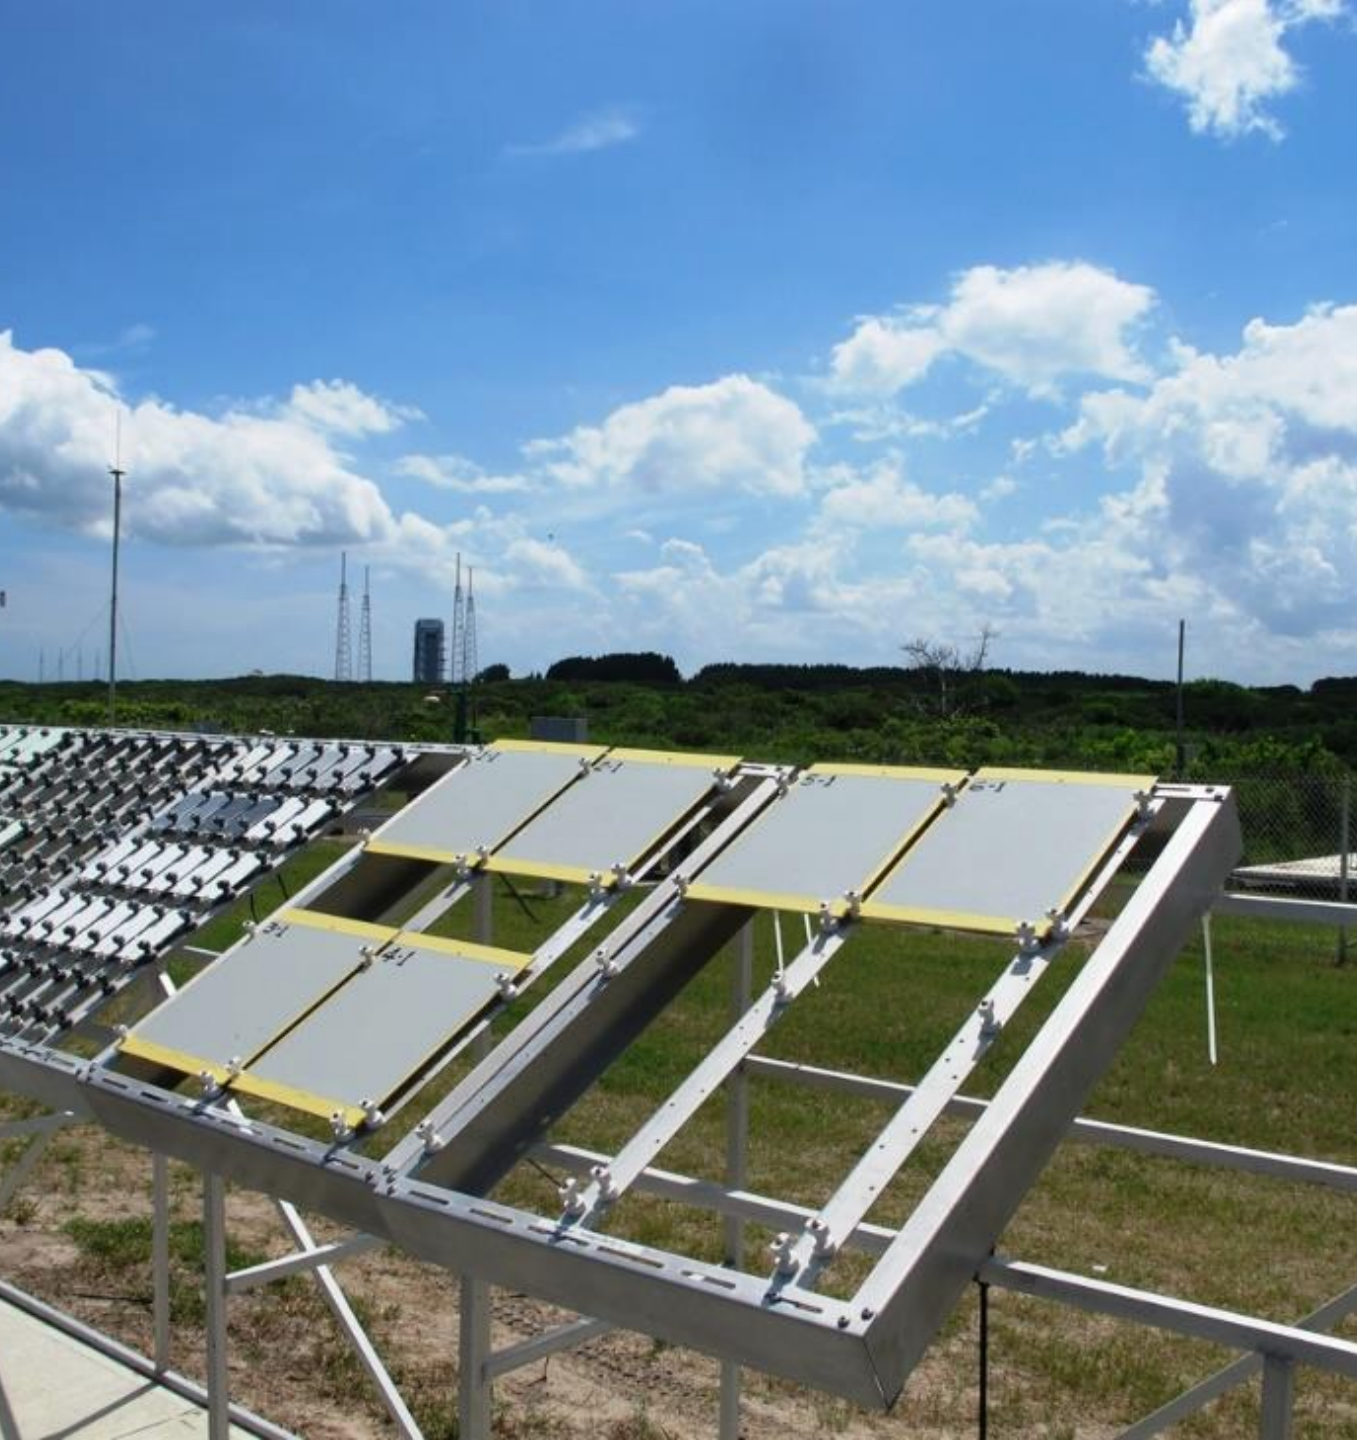
- Rack designed according to ASTM G50
- Scribe test performed at regular intervals (ASTM D1654)
- Adhesion Pull test performed at regular intervals (ASTM D4541)

PANELS DEPICTED AS
INSTALLED AT

NASA BEACHSIDE CORROSION
TESTING FACILITY

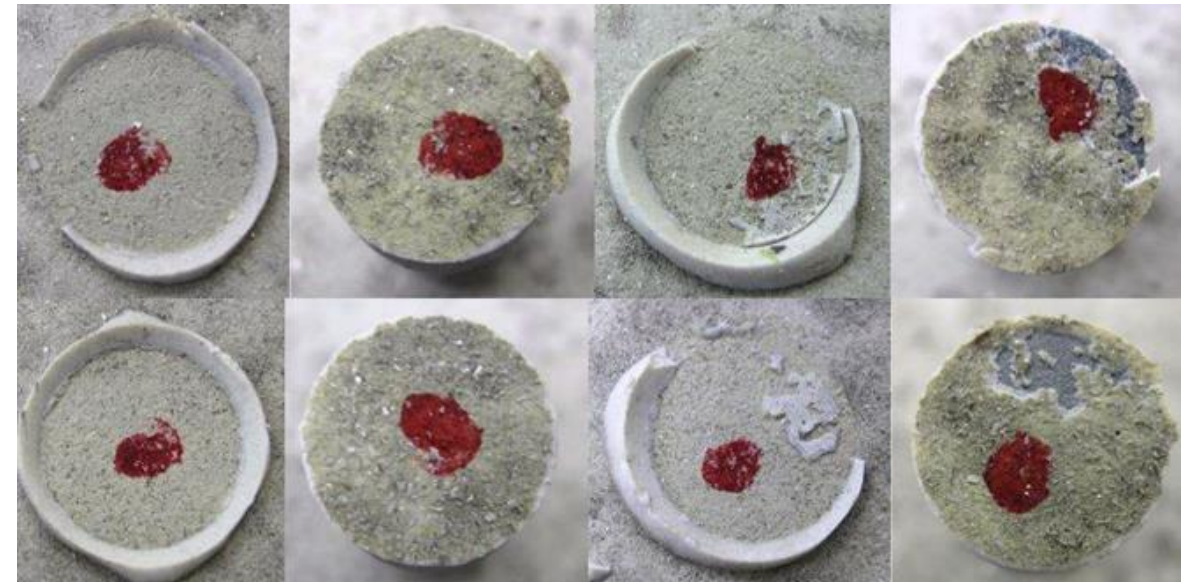
Adhesion Pull-off Test Detail

- Four Adhesion pull-off tests made per panel in successive years (2018-2021)
- Locations selected at least 3 inches from any scribe test site
- All failures were deemed cohesive
- Some failures 100% cohesive
- Others 95% cohesive, 5% adhesive
 - This is Within tolerance of the test
- Variation from year to year was within the tolerance of the test (not statistically significant)

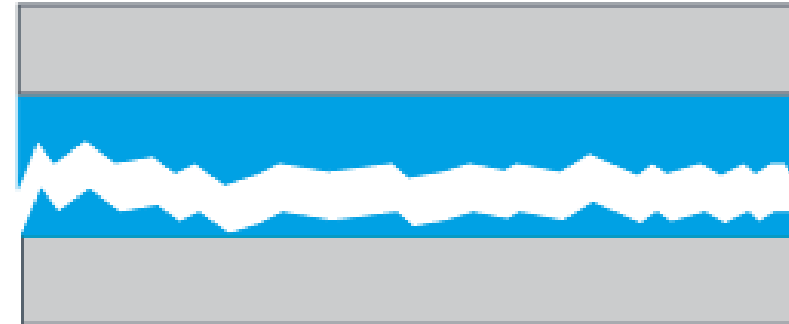
Cohesive failure

- All failures were deemed Cohesive, i.e.:
- Failure point was internal tensile strength of coating rather than strength of adhesion to substrate

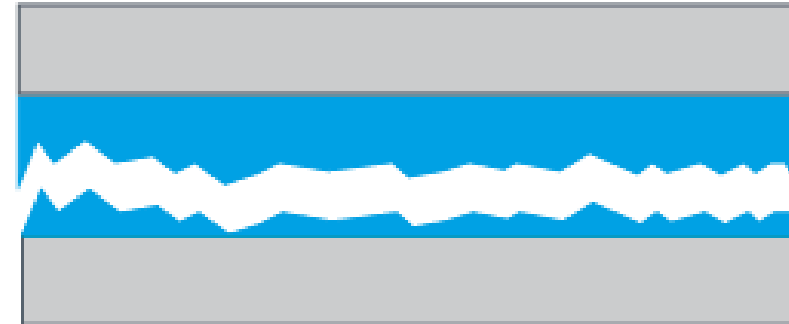
Cohesive failure

- All failures deemed Cohesive, i.e.:
- Failure point was internal tensile strength of coating rather than strength of adhesion to substrate
